# No. 93 STAMFORD ROAD

Renaissance of a Grand Dame

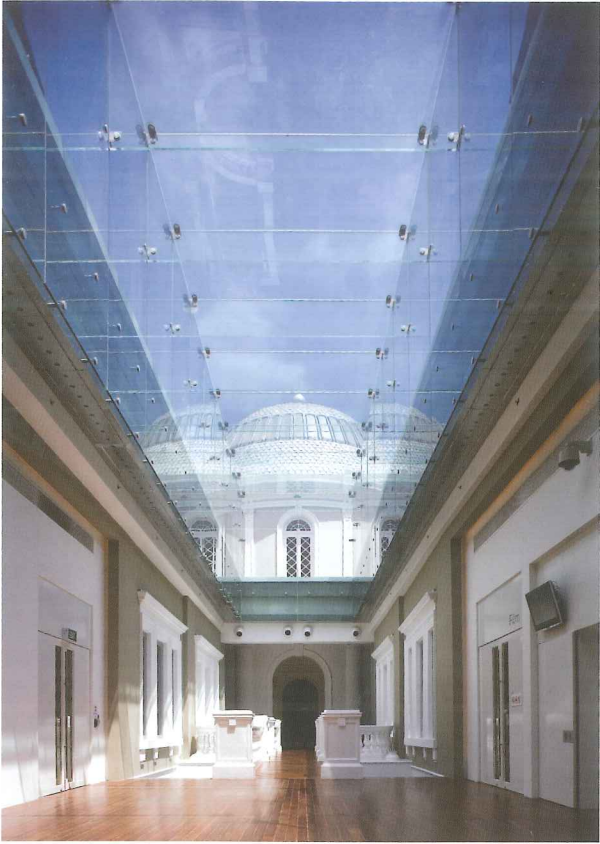
*Sensitive insertion of glass connector for unhindered view of historic dome*

In a somewhat bold move, part of the original tiled roof was cut away to incorporate a glass connector between the front and rear blocks of the old building. Sensitive executed, this glass passage now gives visitors an unhindered view of the museum's historic dome, and functions as a visual link between the past and present.

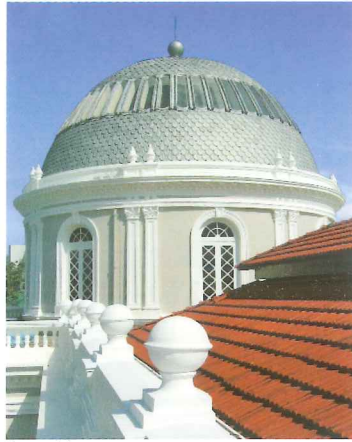
*Restored dome*

The zinc fish-scale tiles of the dome were carefully taken down, cleaned and checked for damage or cracks. If there were cracks, they were repaired and spray-coated thrice. Damaged ones were replaced with new fabricated tiles. These were reinstalled from bottom-up in original order with rusty screws replaced.

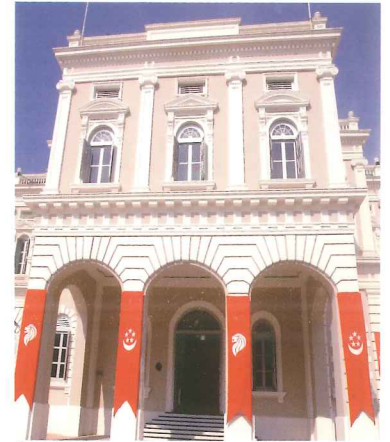
*Entrance to museum retained and restored*

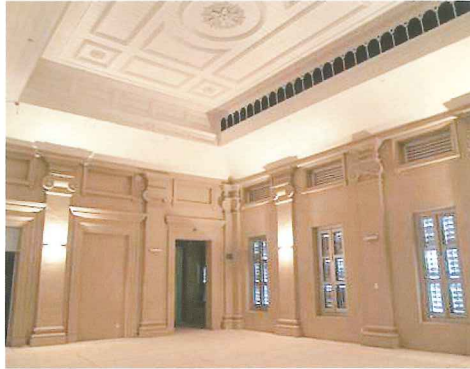
*Decorative ceiling and pilasters kept*

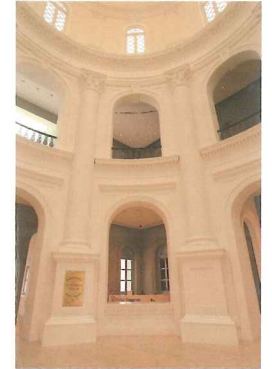
*Opening up of original niches of rotunda for visual connectivity*

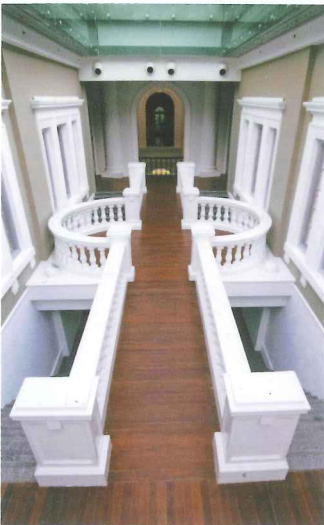
*Seamless timber floor finish matching second storey central circulation*
